# Chooralmala, Wayanad, Kerala, India

## Landslide Impact Map

Observed on 31/07/2024

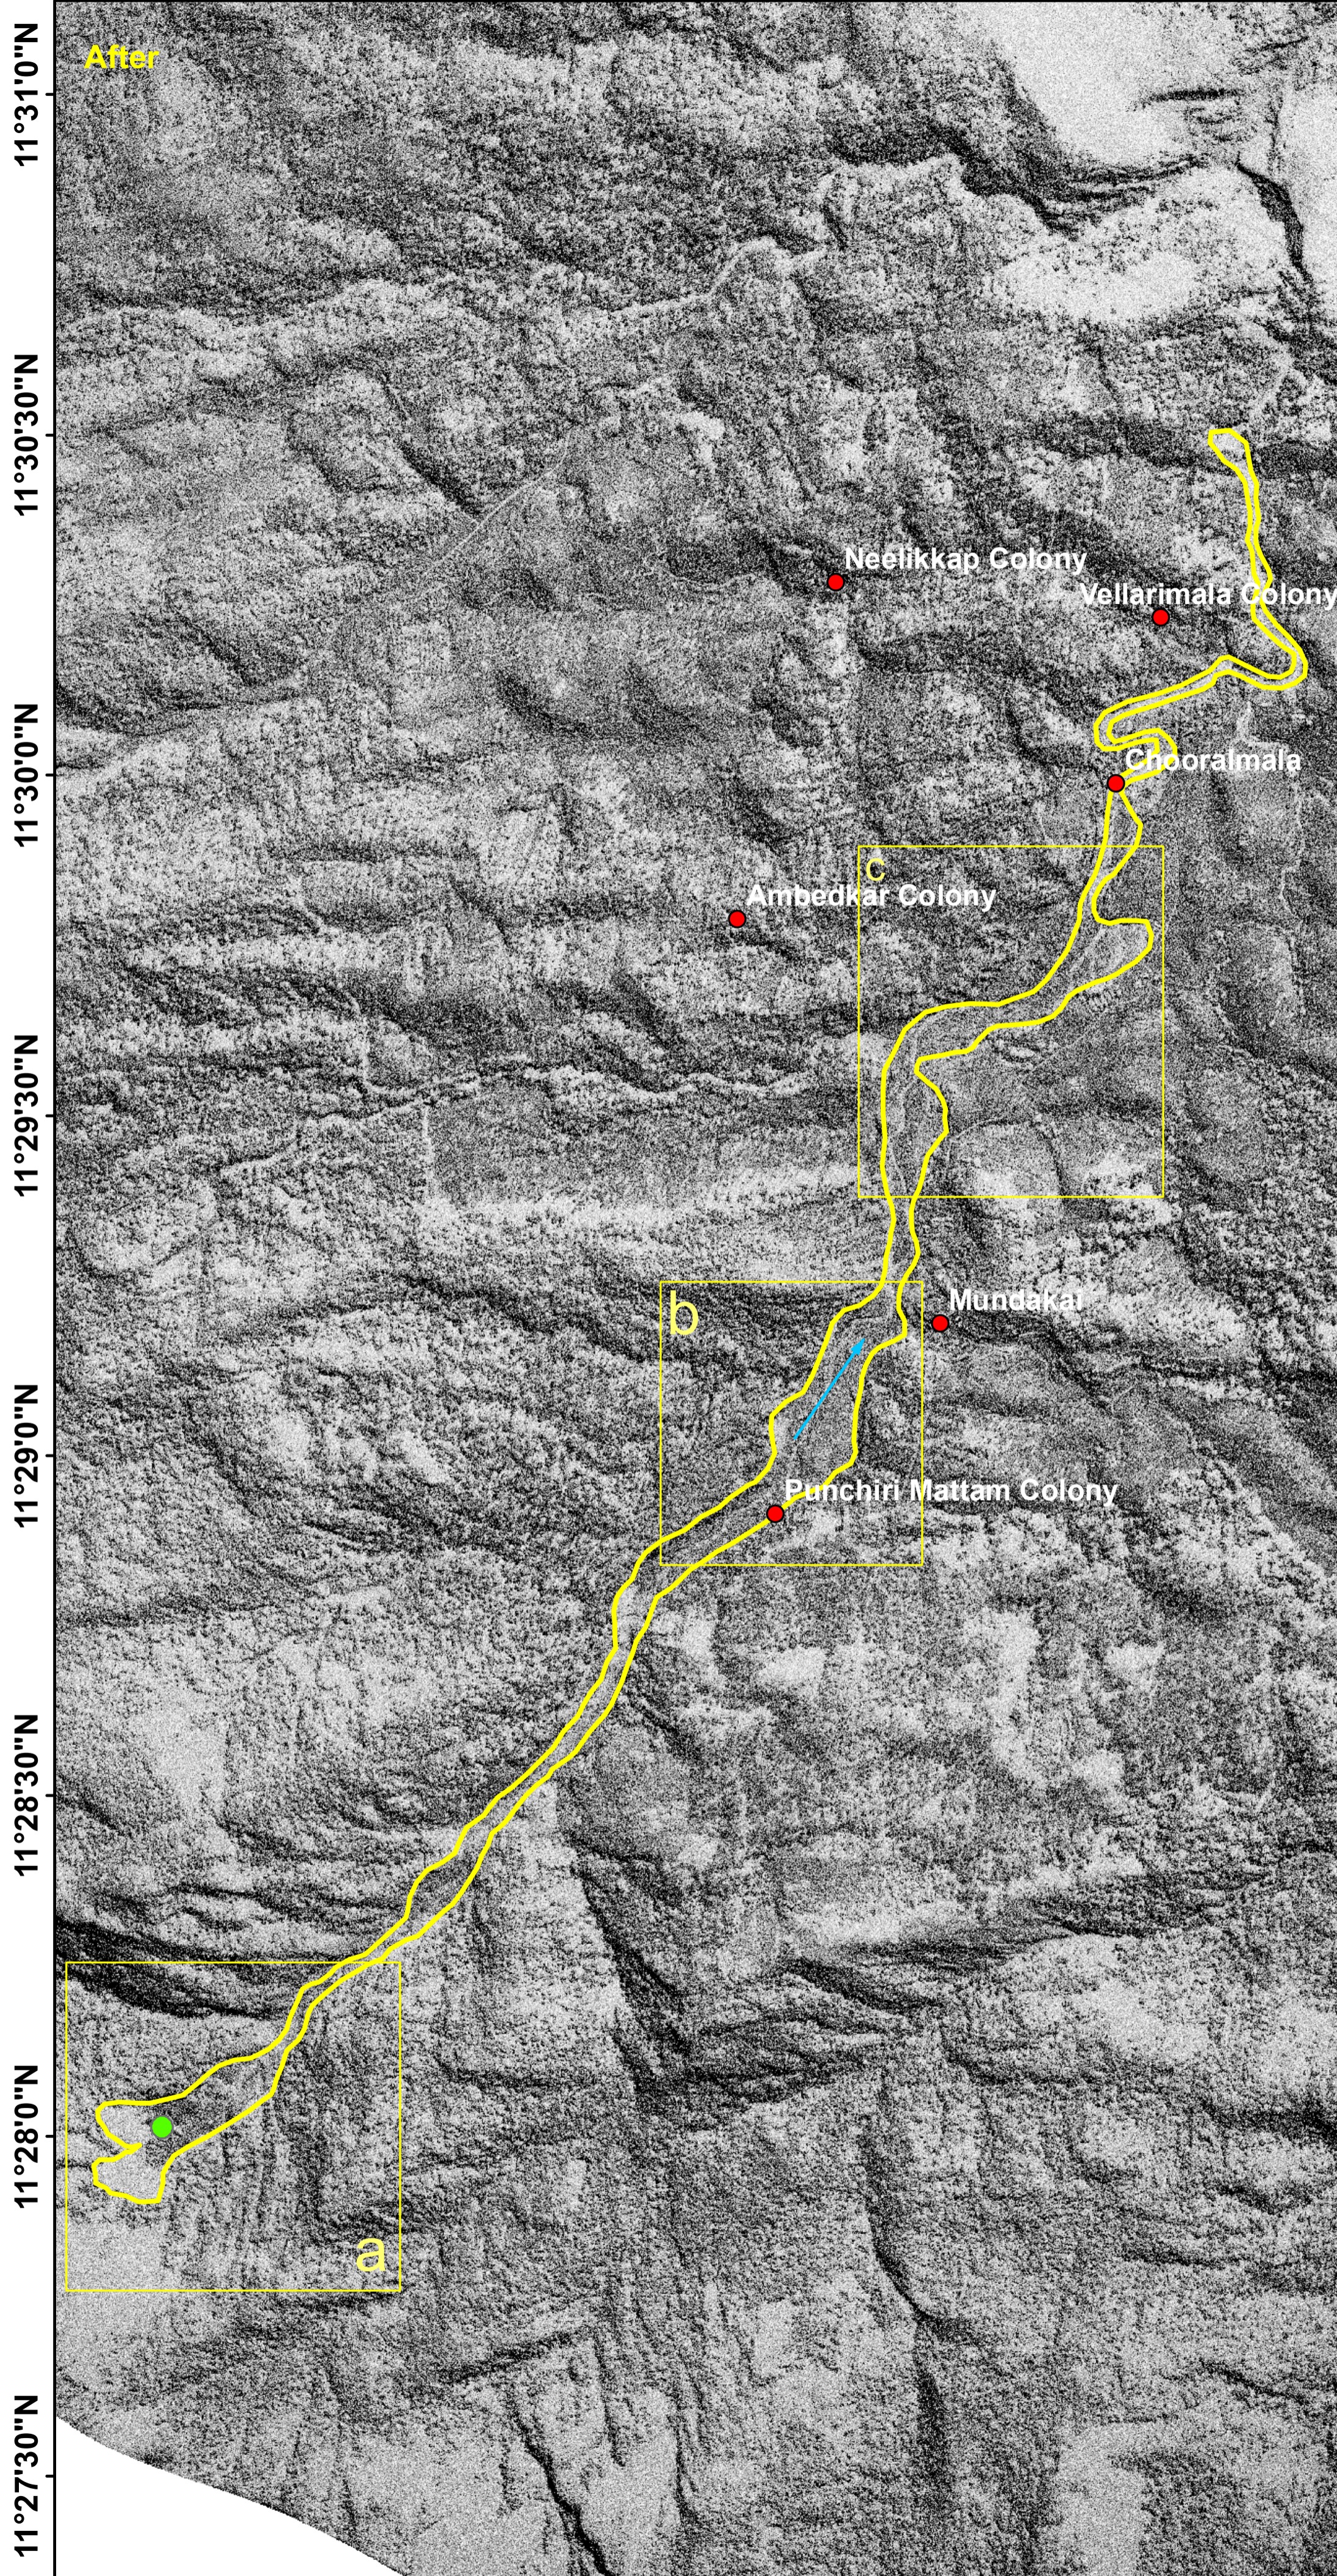
A major debris flow was triggered by heavy rainfall in and around the Chooralmala town of Wayanad District in Kerala state of India. As per latest reports, more than 100 people are dead and many are missing. Very high resolution RISAT SAR images of 31 July, 2024 shows the entire extent of the debris flow from crown to end of run out zone. The approximate length of the flow is ~ 8 km. The crown zone is a reactivation of an older landslide. The size of the main scarp of the landslide in 86,000 sq.m. The debris flow has widened the course of the Iruvanipuzha river causing breach of its banks. Houses and other infrastructures located along the banks have been damaged by the debris flow.
